# Situation Photo Log

Friday, December 7, 2012

Kalamazoo River / Enbridge Spill

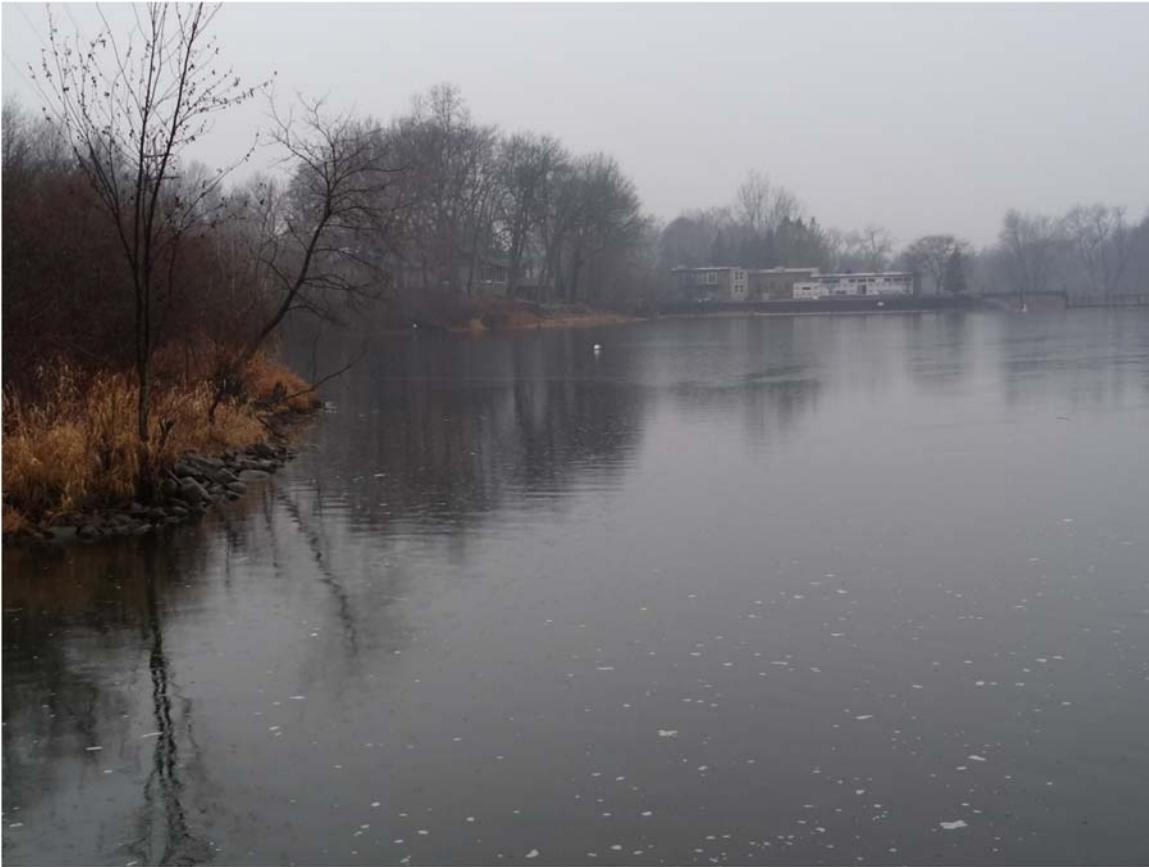
1. MP5.63 area where sheen and tar globs were observed. Sheen appeared to be generated by the Bathymetry team's boat.

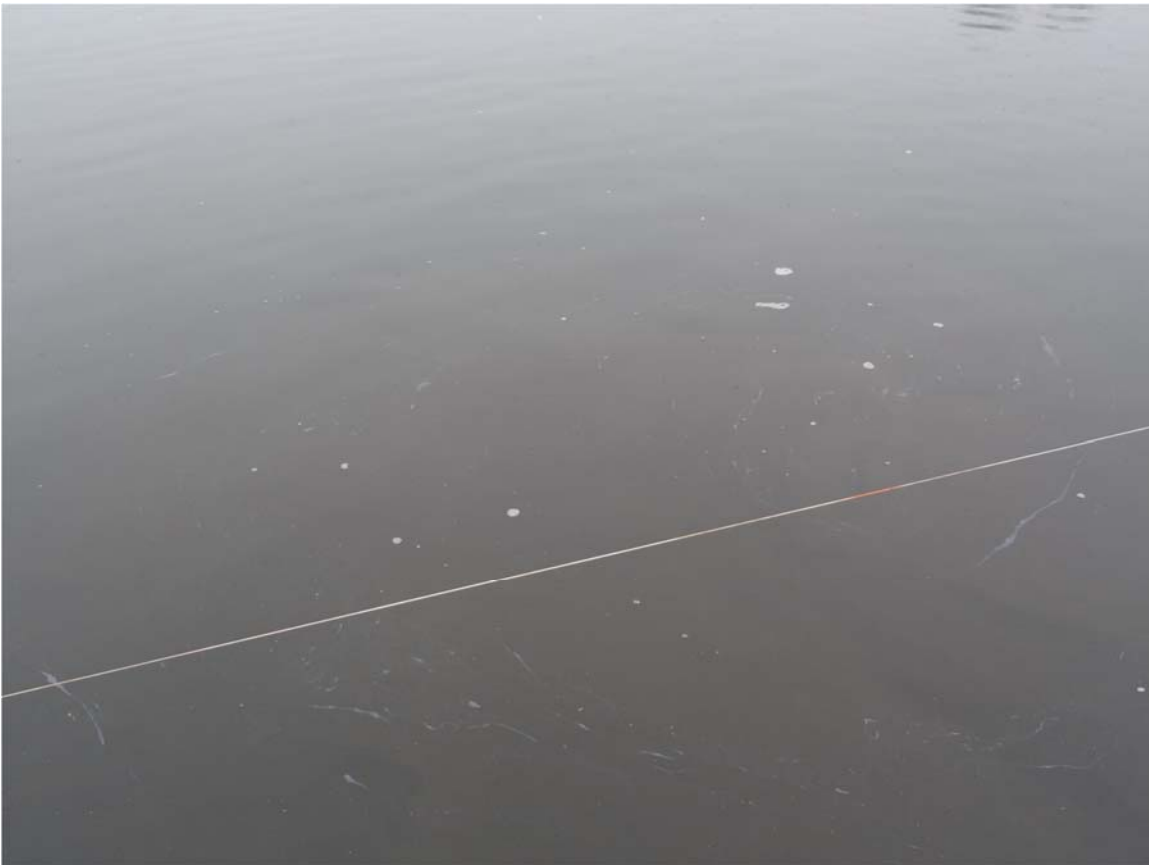
2. MP5.63 sheen and tar globs observed. Sheen appeared to be generated by the Bathymetry team's boat. Sweep boat requested.

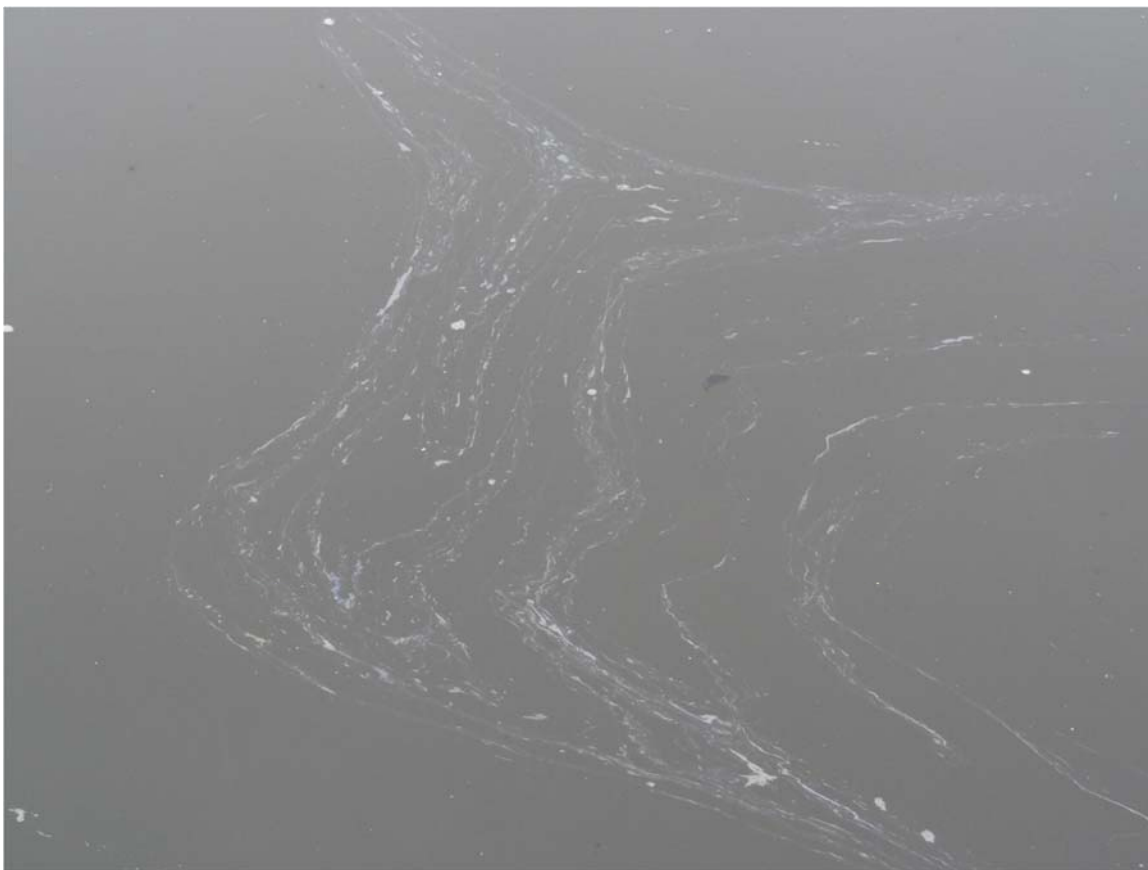
3. MP5.63 sheen and tar globs observed. Sheen appeared to be generated by the Bathymetry team's boat. Sweep boat requested.

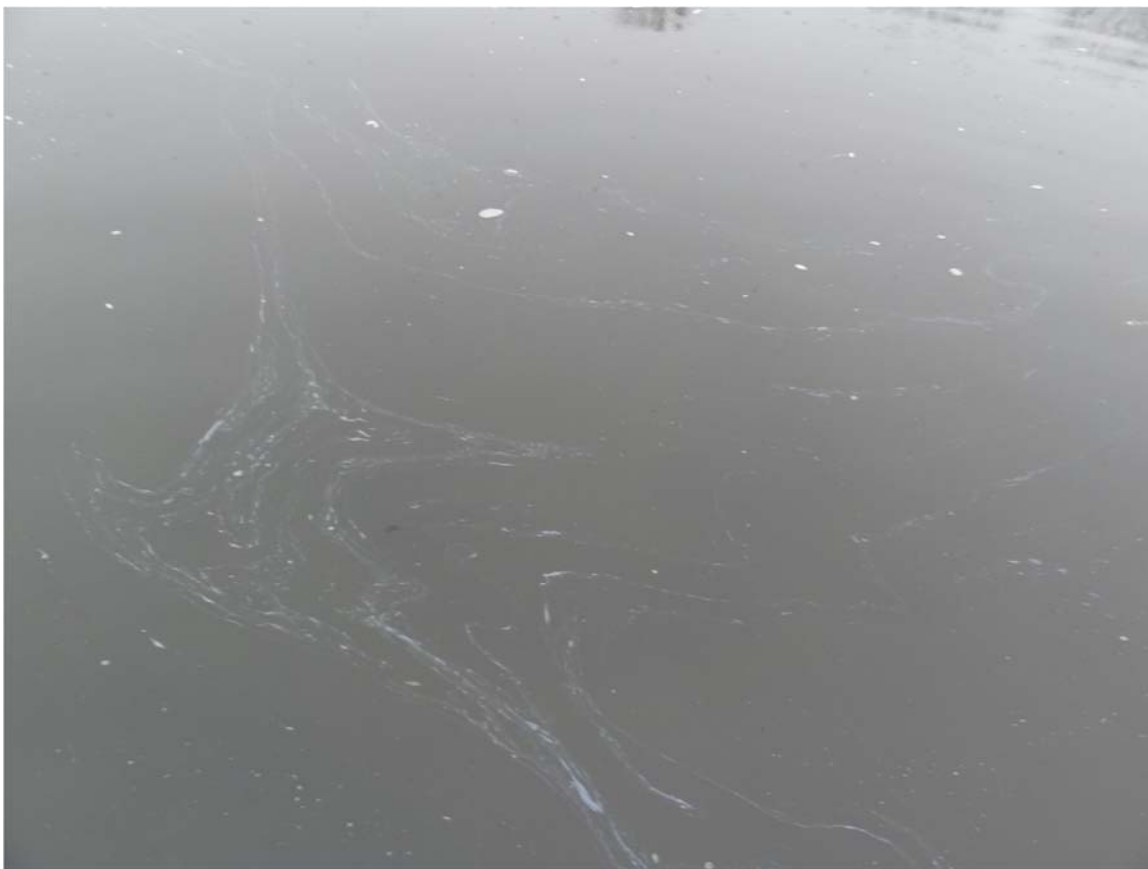
4. MP5.63 sheen and tar globs observed. Sheen appeared to be generated by the Bathymetry team's boat. Sweep boat requested

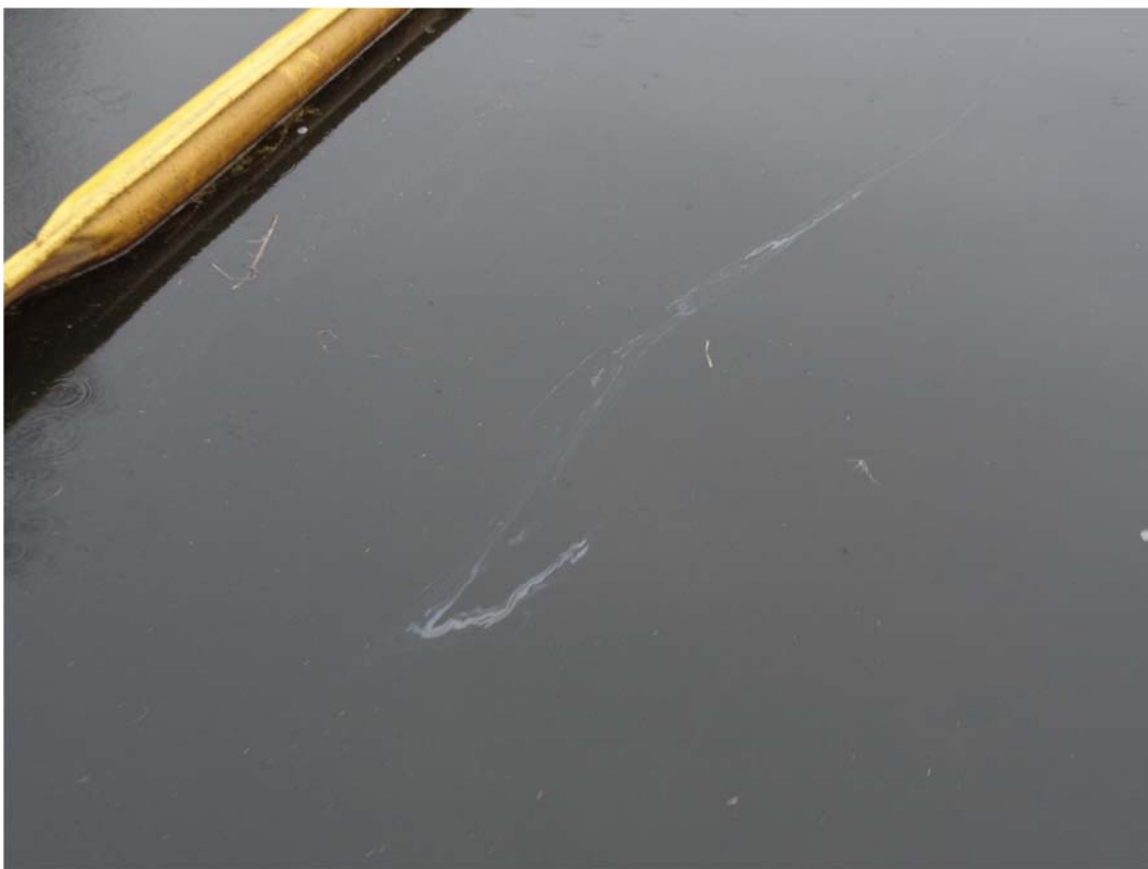
6. Ceresco Dam control point boom observed sheen and tar globs collecting along the boom.

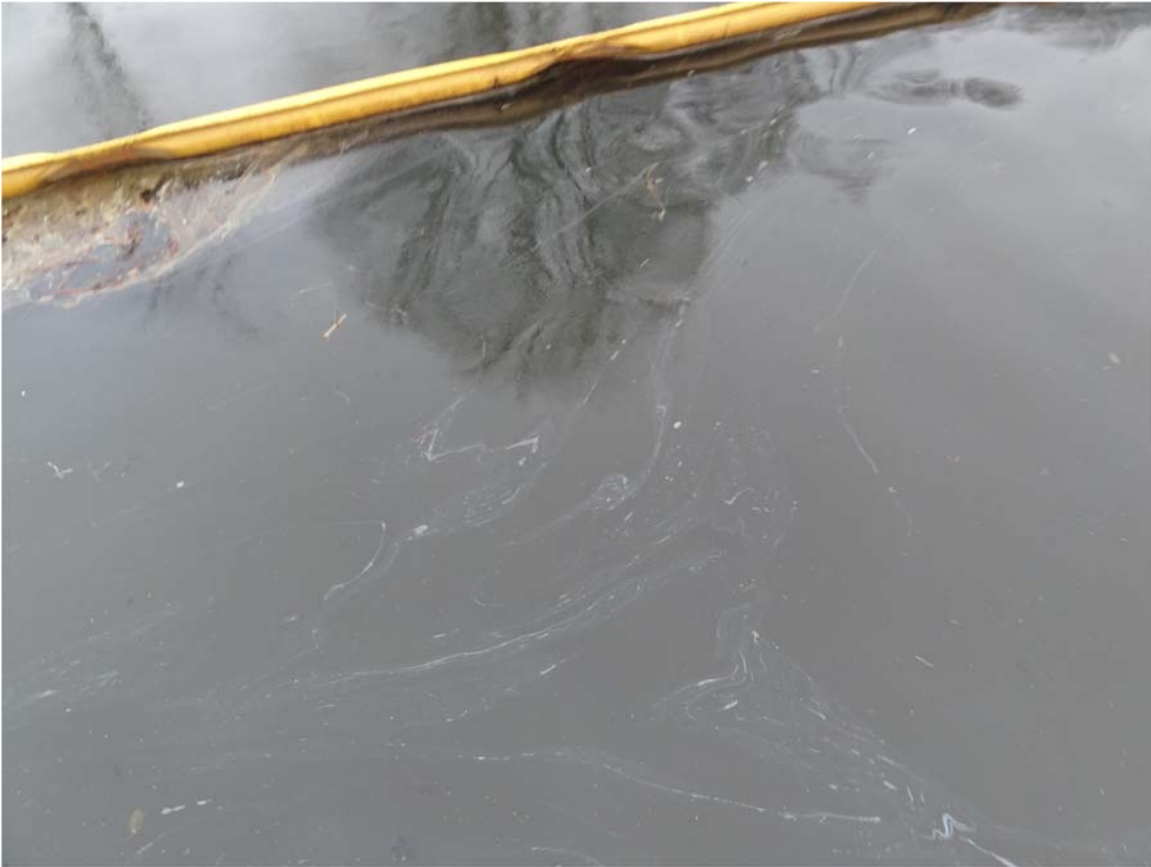
**7. Observed sheen and tar globs collecting along the upper end of the control point boom. Sheen appeared to be generated from the bathymetry team boats. Sweep boat was requested.**

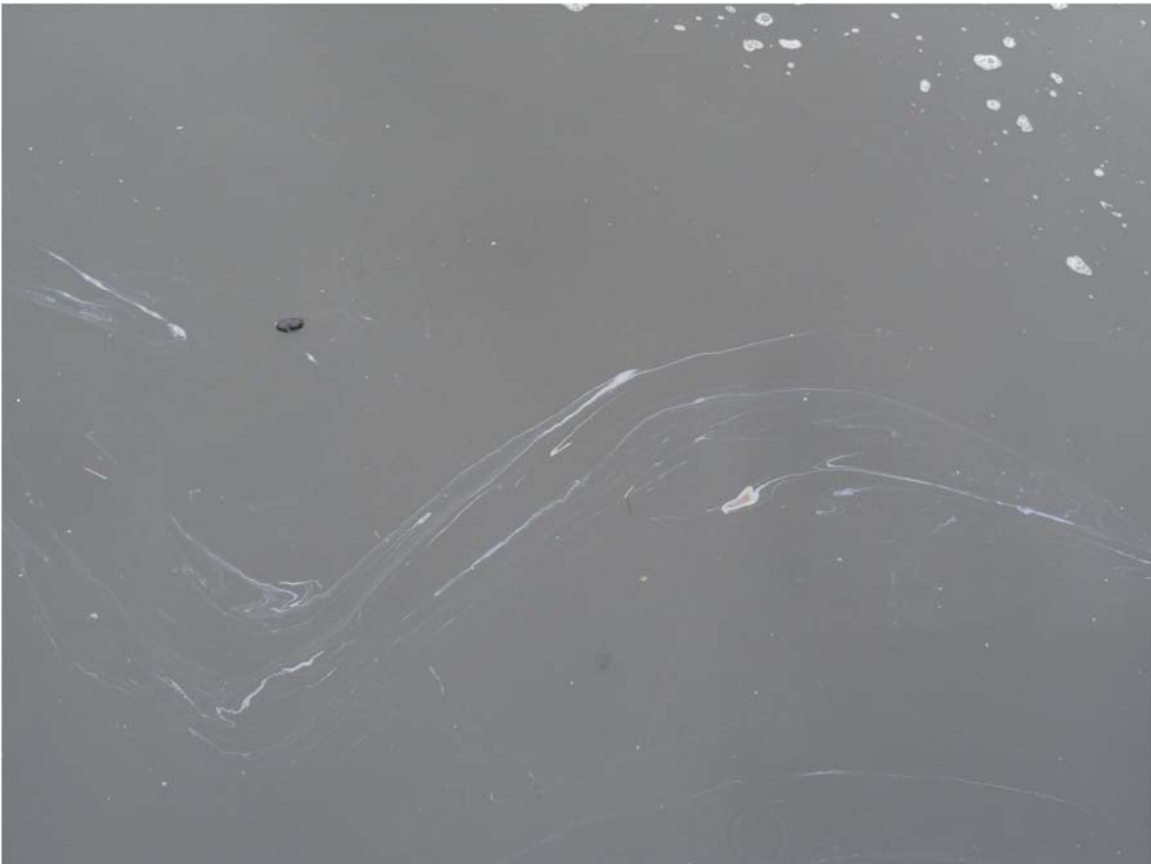
**8. Observed sheen and tar globs collecting along the upper end of the control point boom. Sheen appeared to be generated from the bathymetry team boats. Sweep boat was requested.**

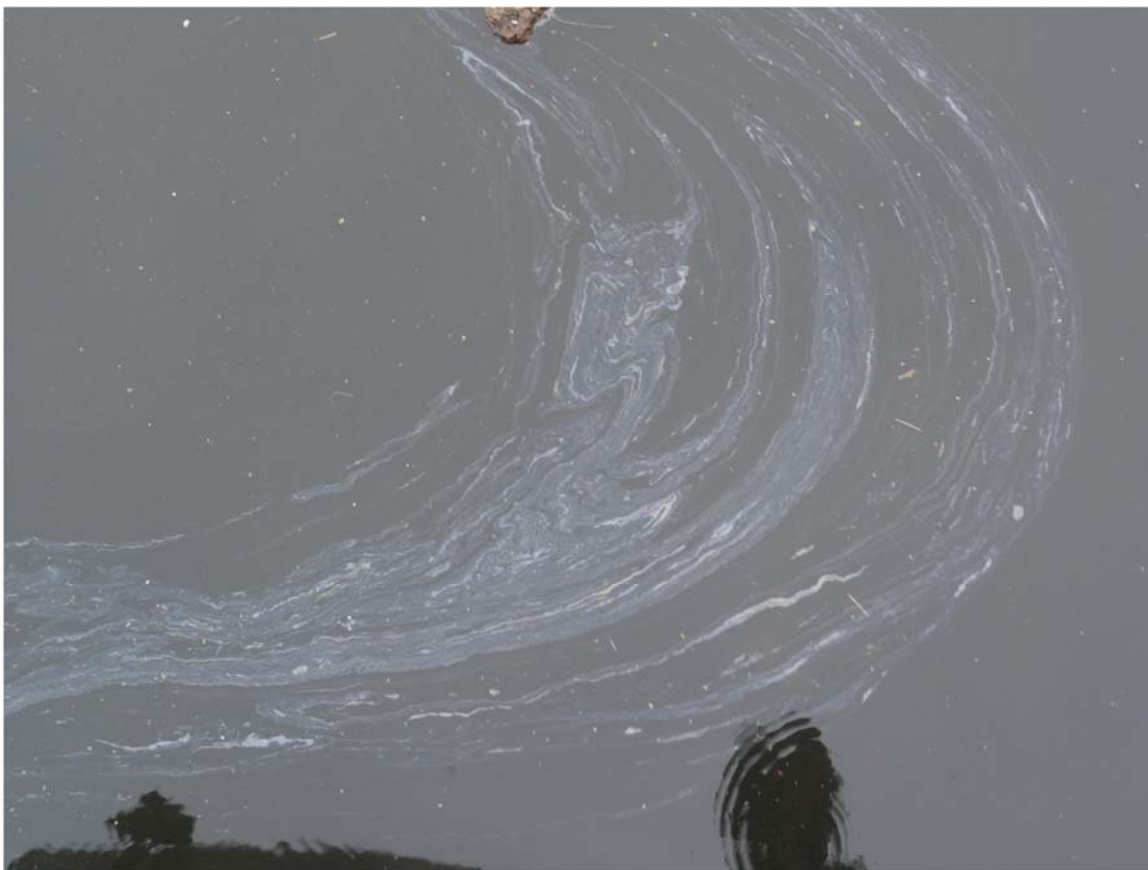
9. MP5.70 RDB sheen and tar globs. Sheen appeared to be generated from the bathymetry team boats. Sweep boat was requested.

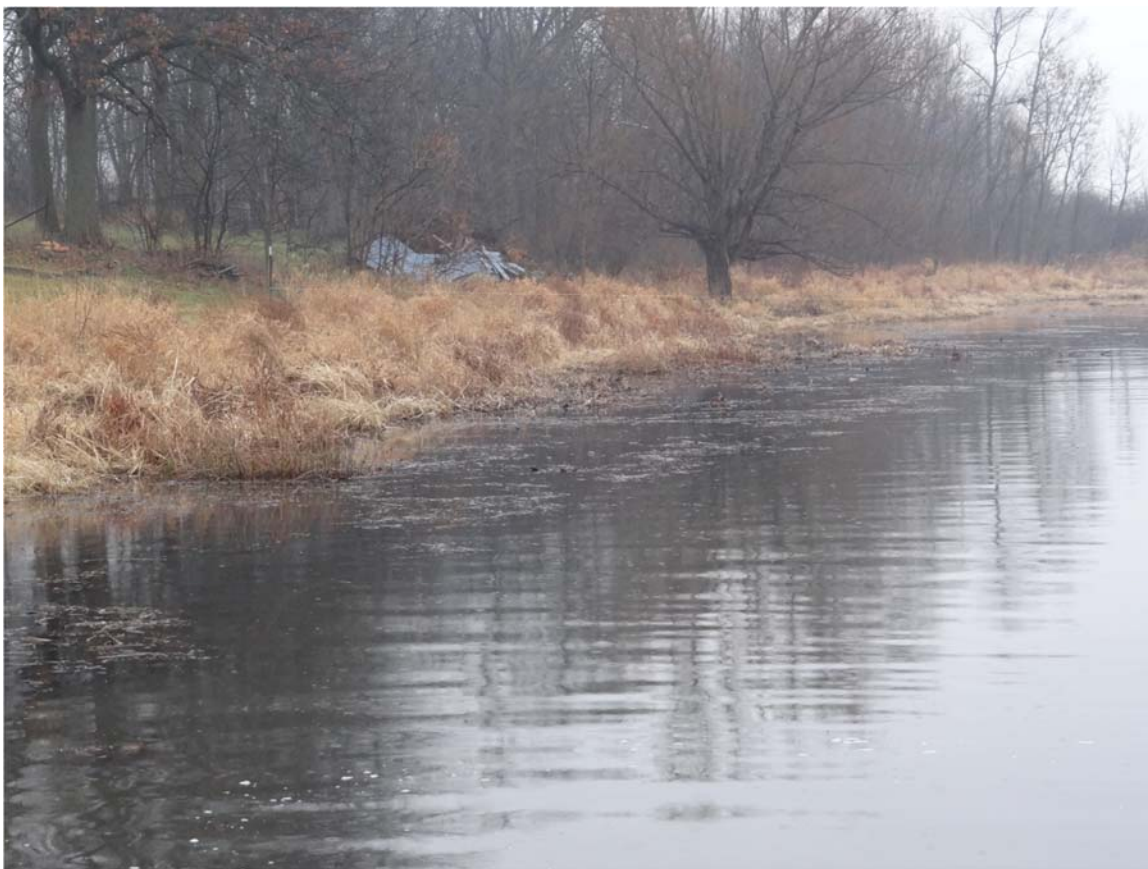
10. MP5.70 RDB area where sheen and tar globs were observed. .

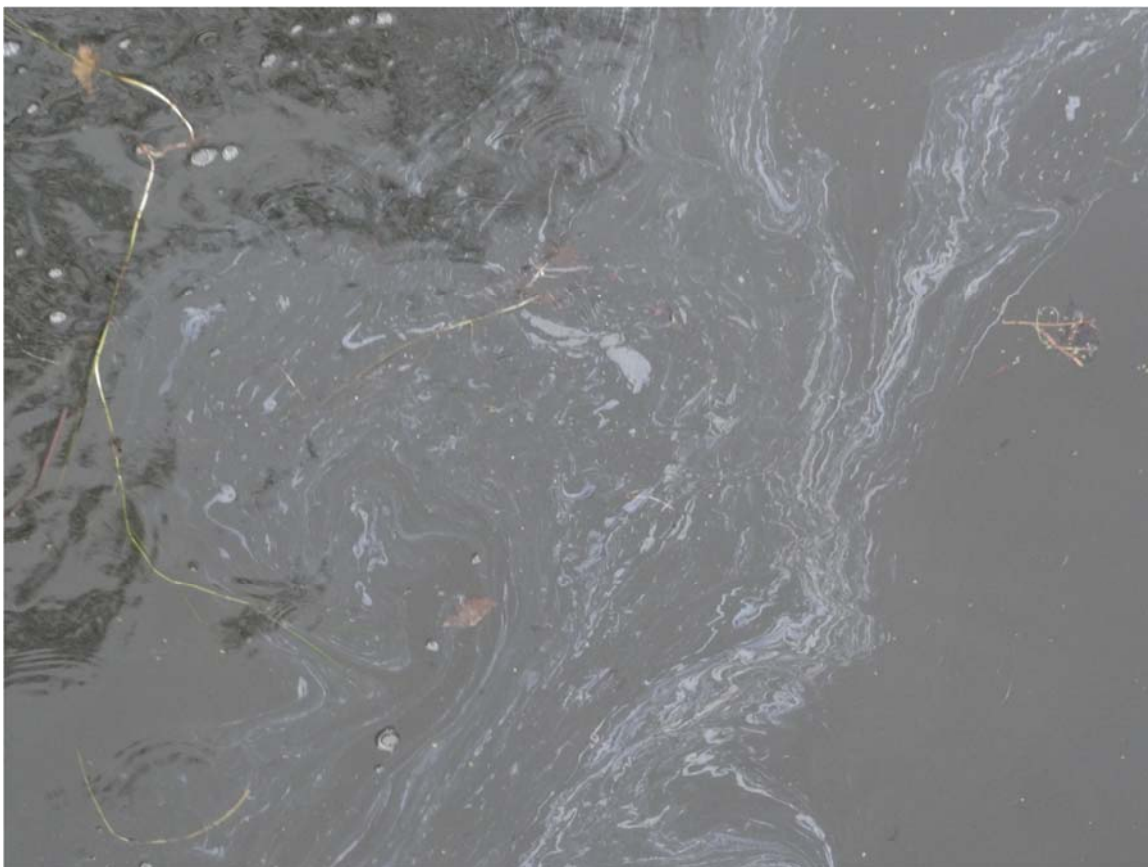
**11. MP5.70 RDB sheen and tar globs. Sheen appeared to be generated from the bathymetry team boats. Sweep boat was requested.**

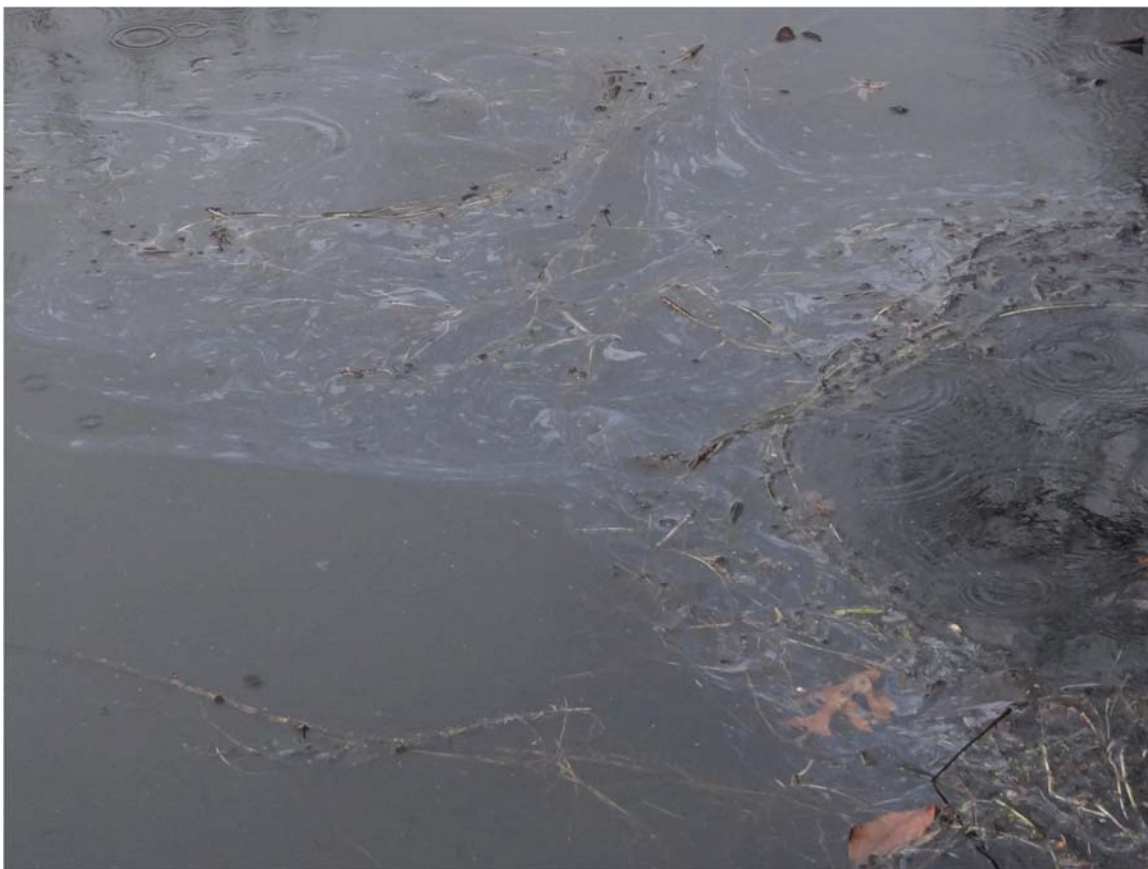
**12. MP5.70 RDB sheen and tar globs. Sheen appeared to be generated from the bathymetry team boats. Sweep boat was requested.**

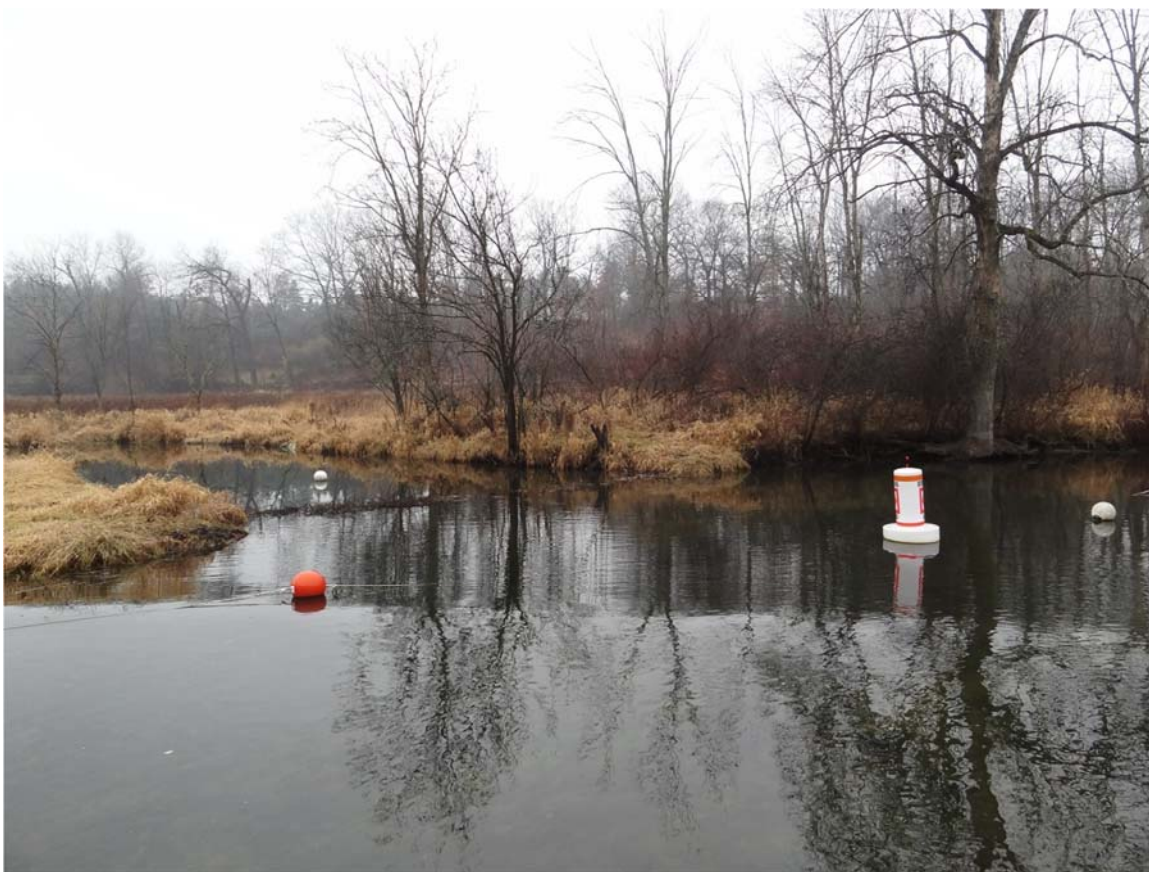
**13. MP10.75 Sediment Trap observed sheen on the downstream side of the trap.**

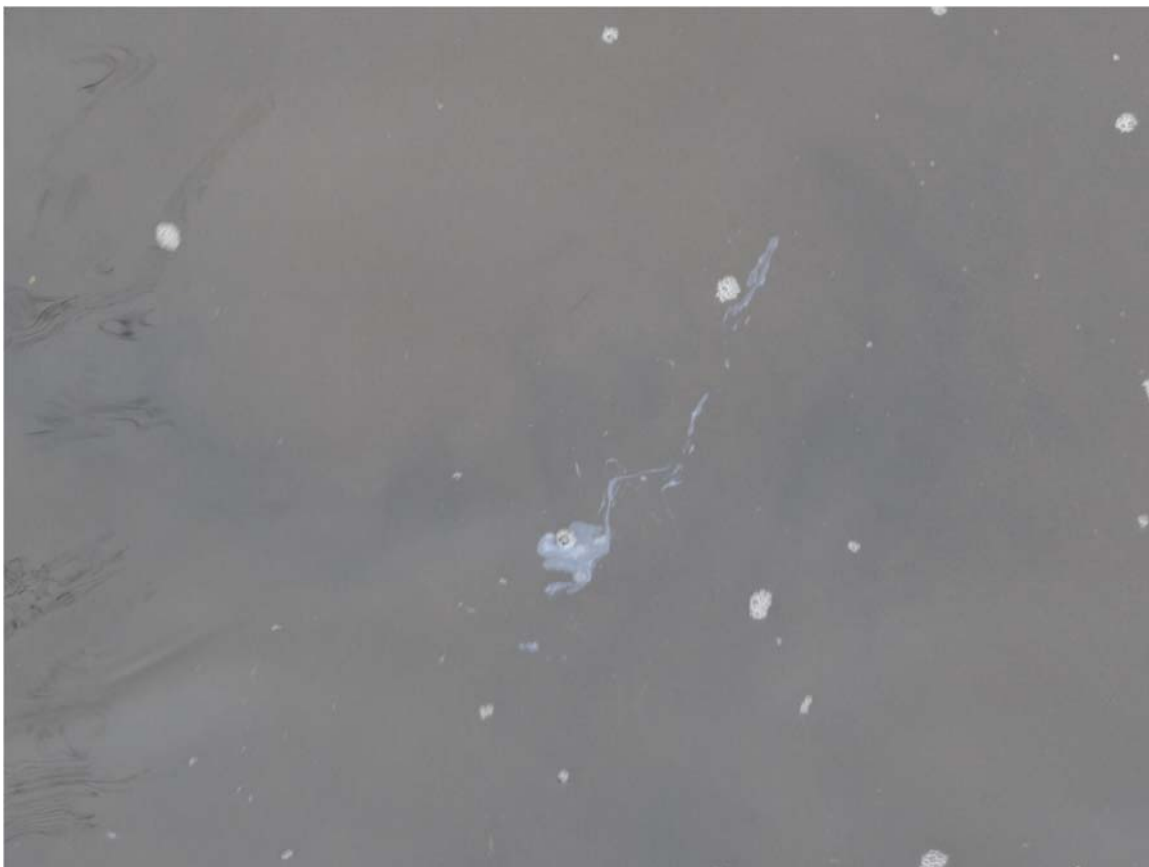
**14. MP10.75 Sediment Trap observed sheen on the downstream side of the trap.**

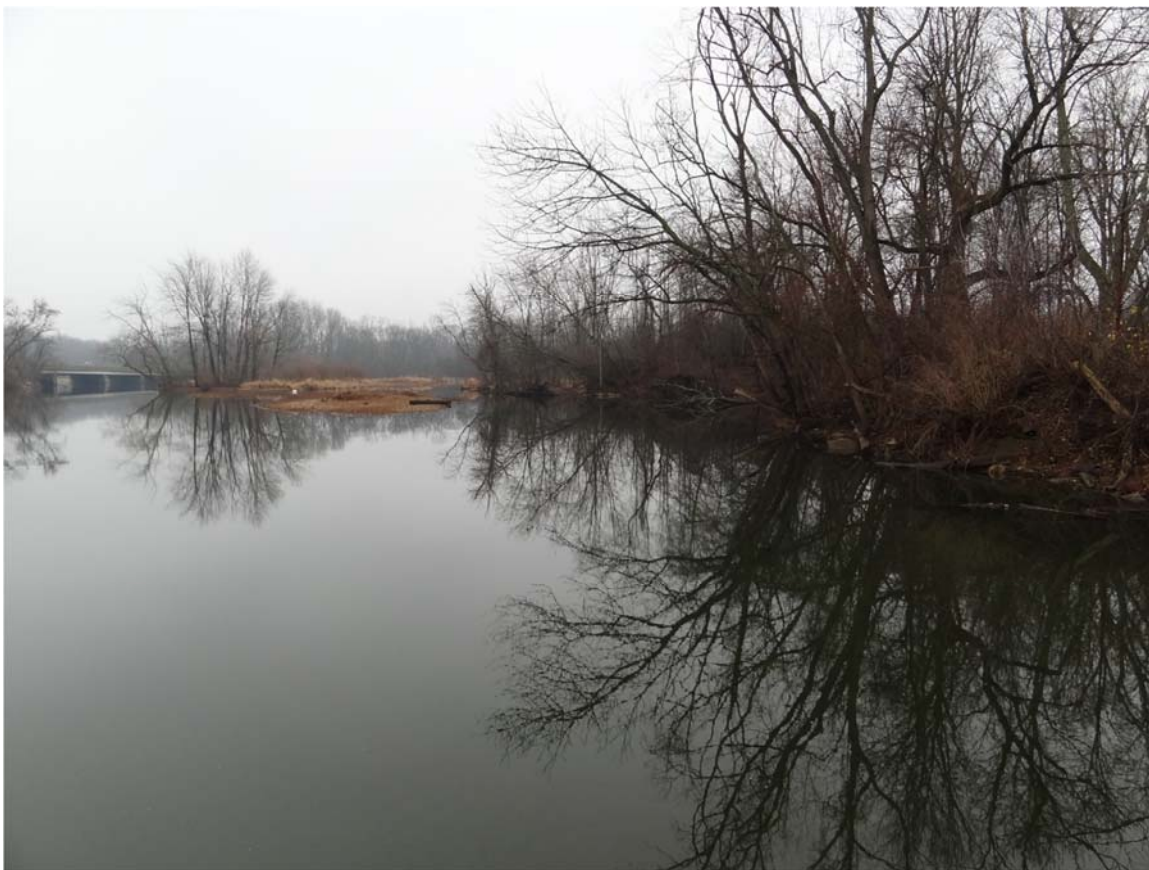
15. MP15.0 LDB area where sheen and tar globs were observed.

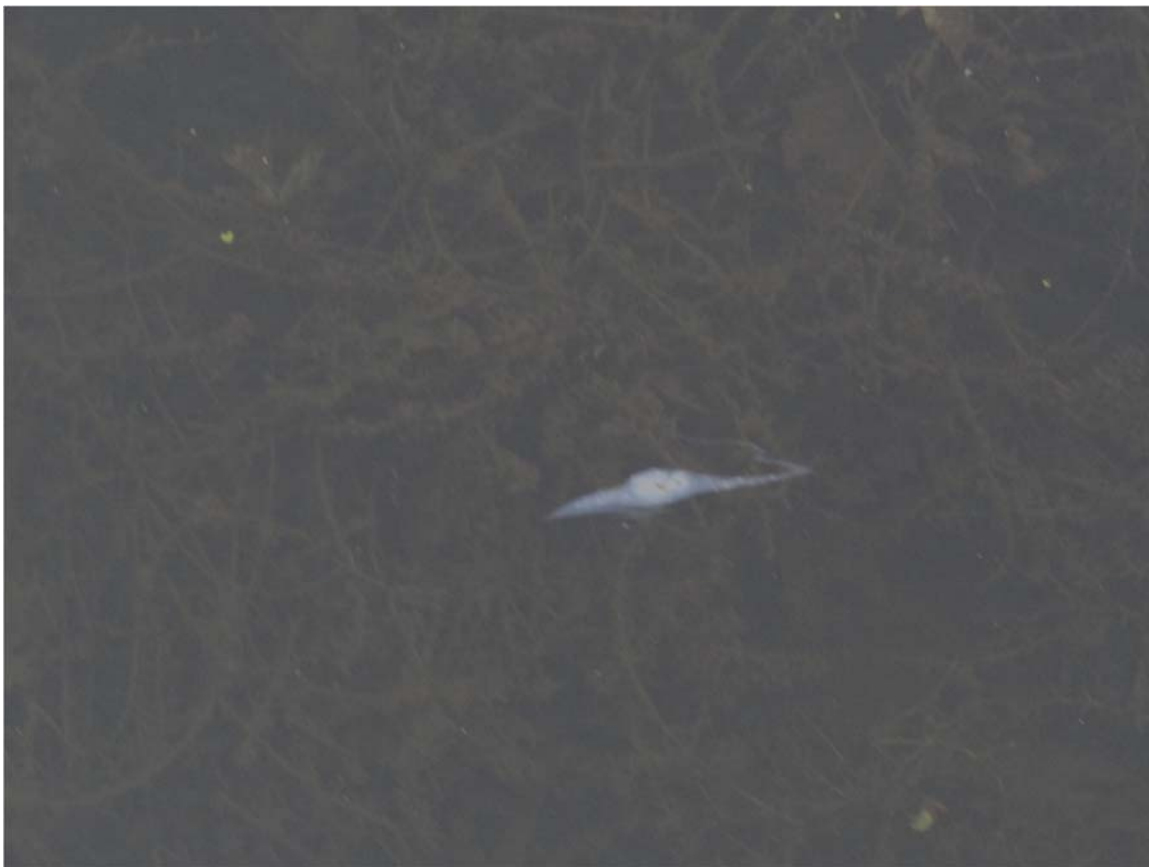
16. MP15.0 LDB sheen and tar globs observed.

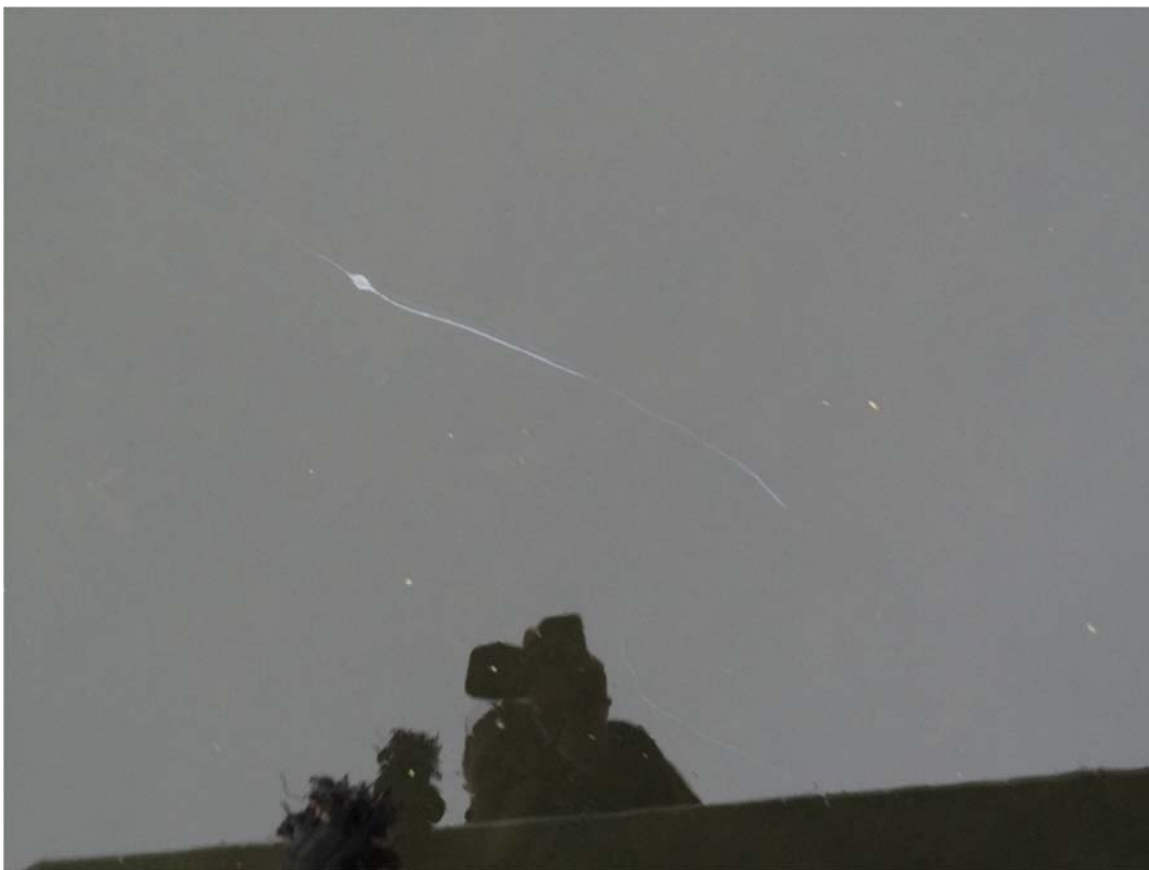
17. MP15.0 LDB sheen and tar globs observed.

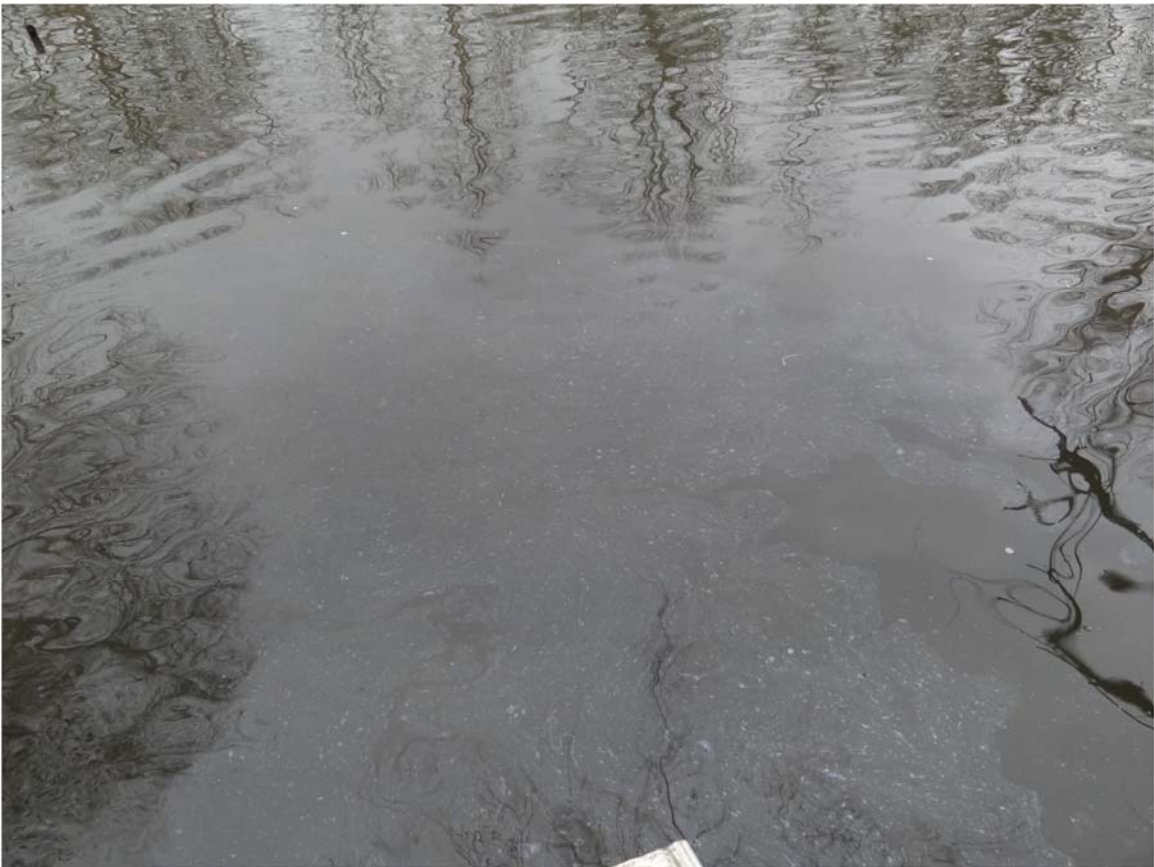
**20. MP28.25 RDB sheen and tar globs observed around the docked boats.  
Sheen sweep requested.**

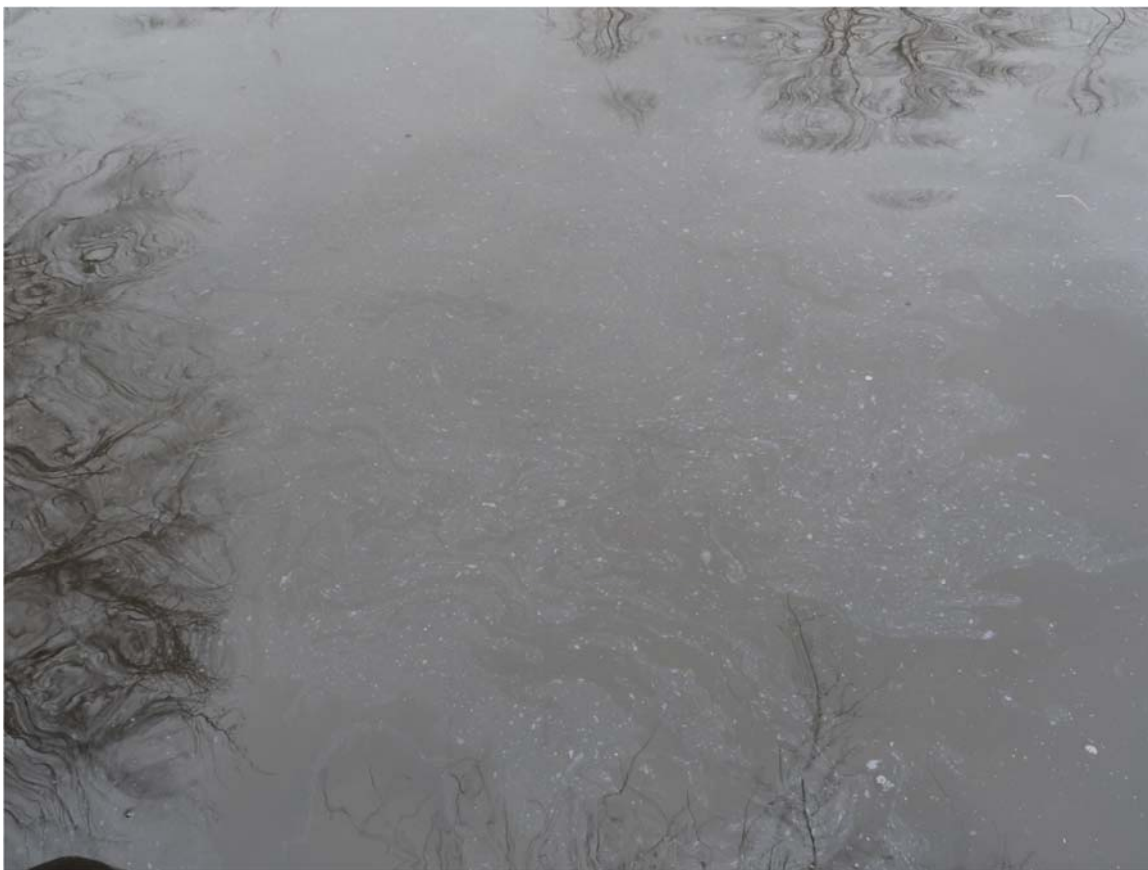
**21. MP28.25 RDB sheen and tar globs observed around the docked boats.  
Sheen sweep requested.**

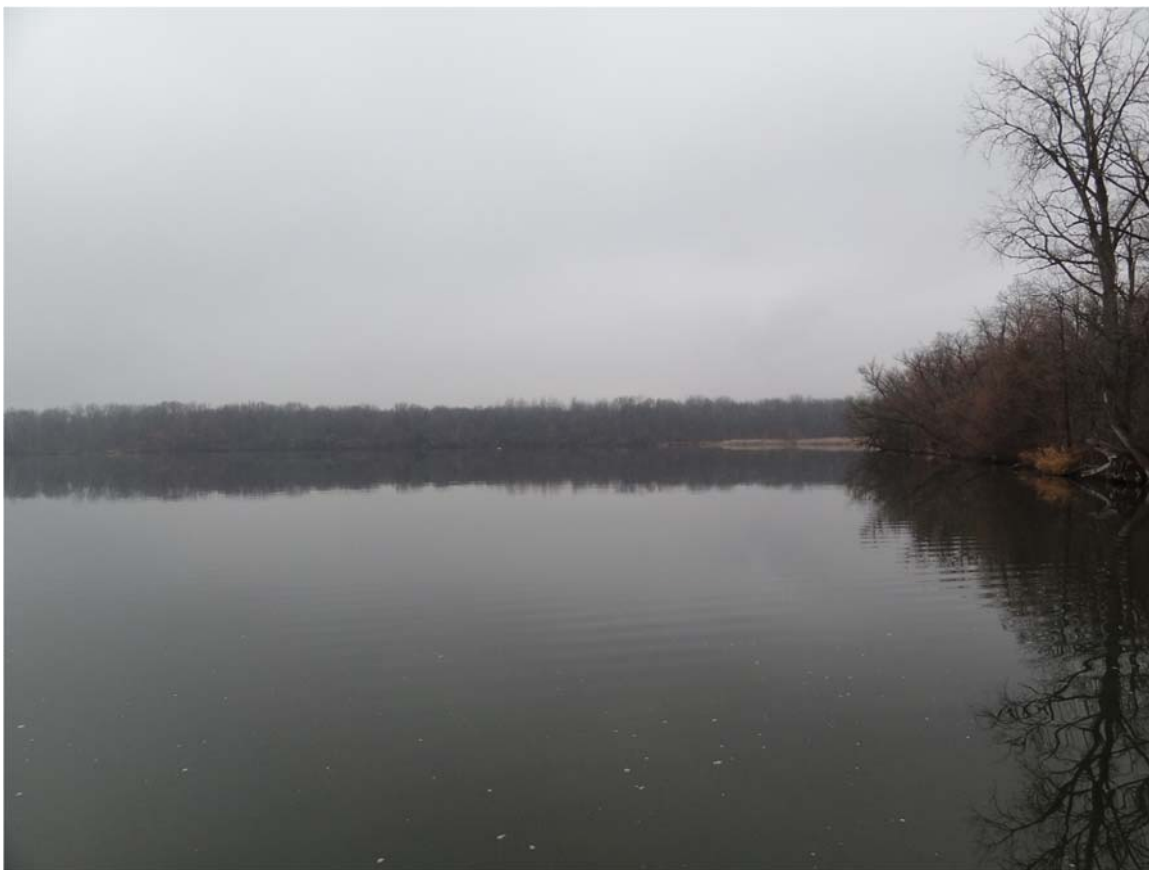
**23. Morrow Lake North Cove area where sheen and tar globs were observed.  
Sheen sweep requested.**

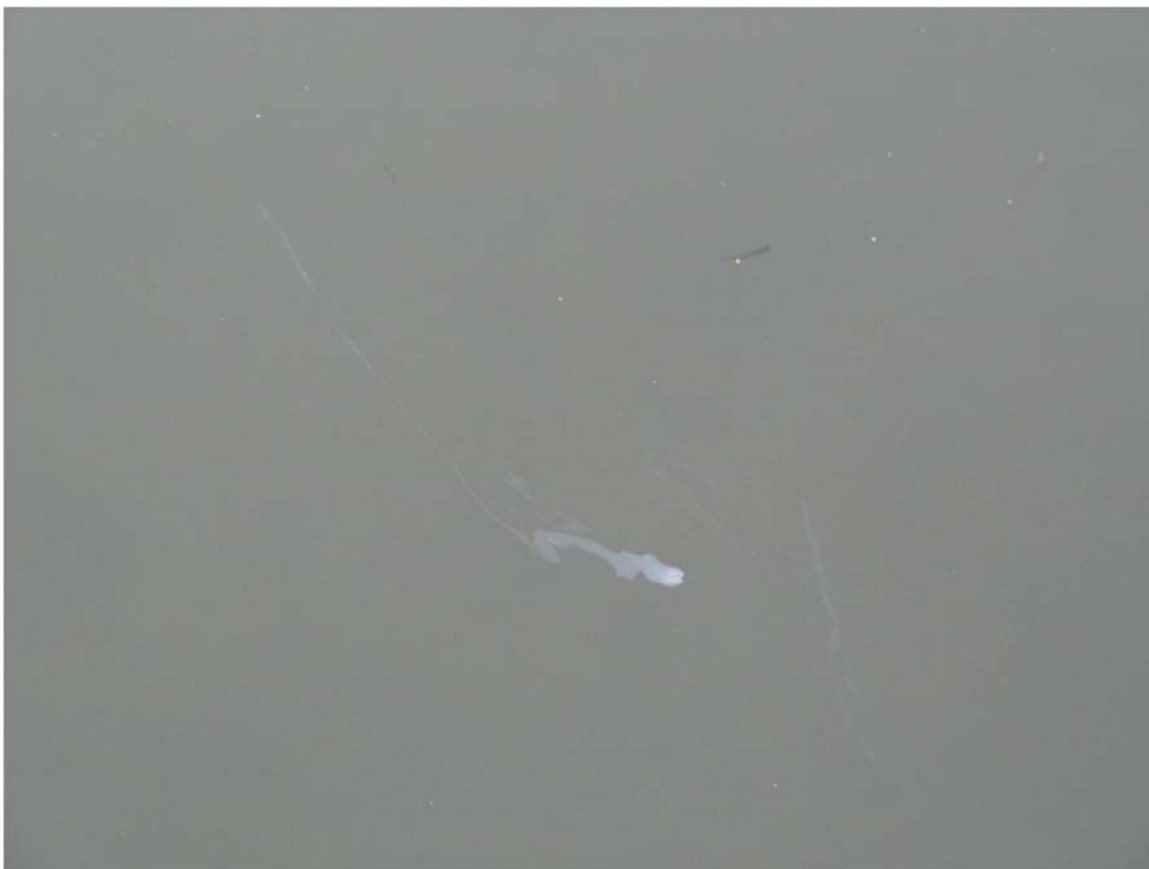
**24. Morrow Lake North Cove sheen and tar globs observed. Sheen sweep  
requested.**

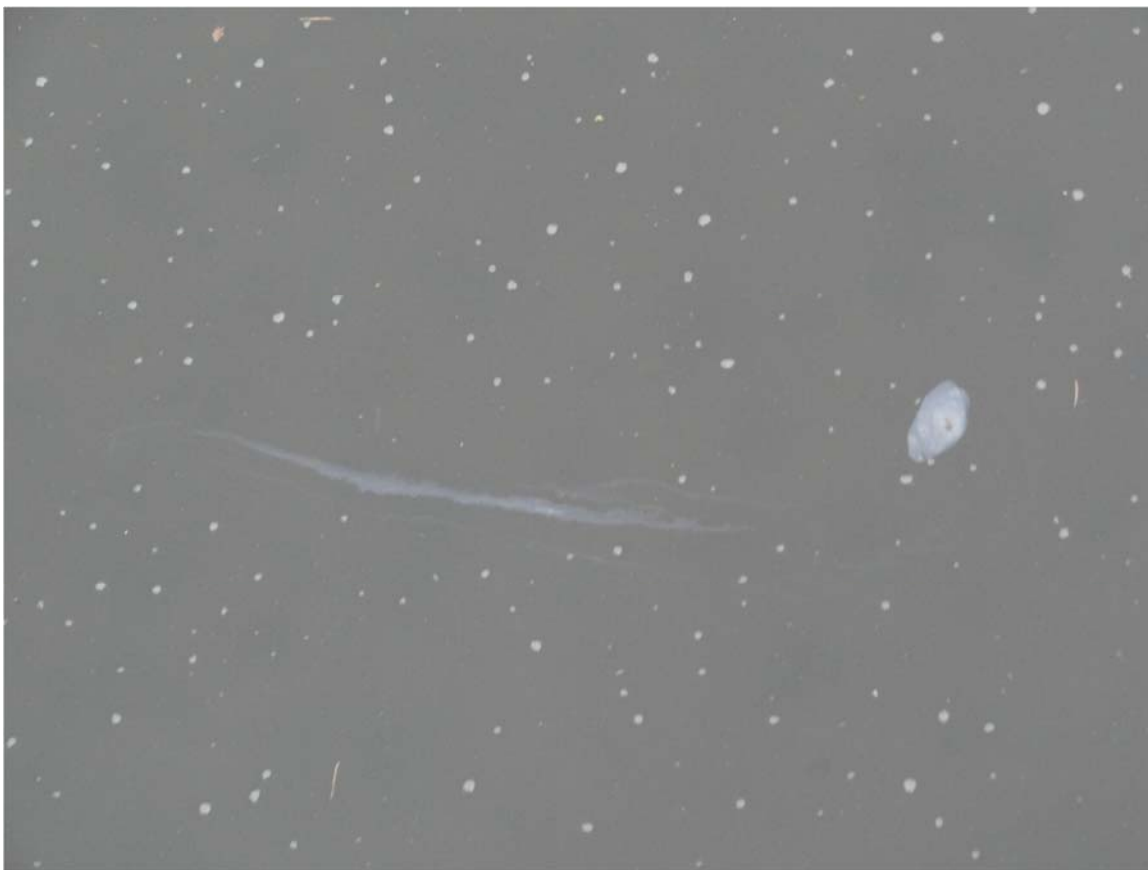
**25. Morrow Lake North Cove sheen and tar globs observed. Sheen sweep requested.**

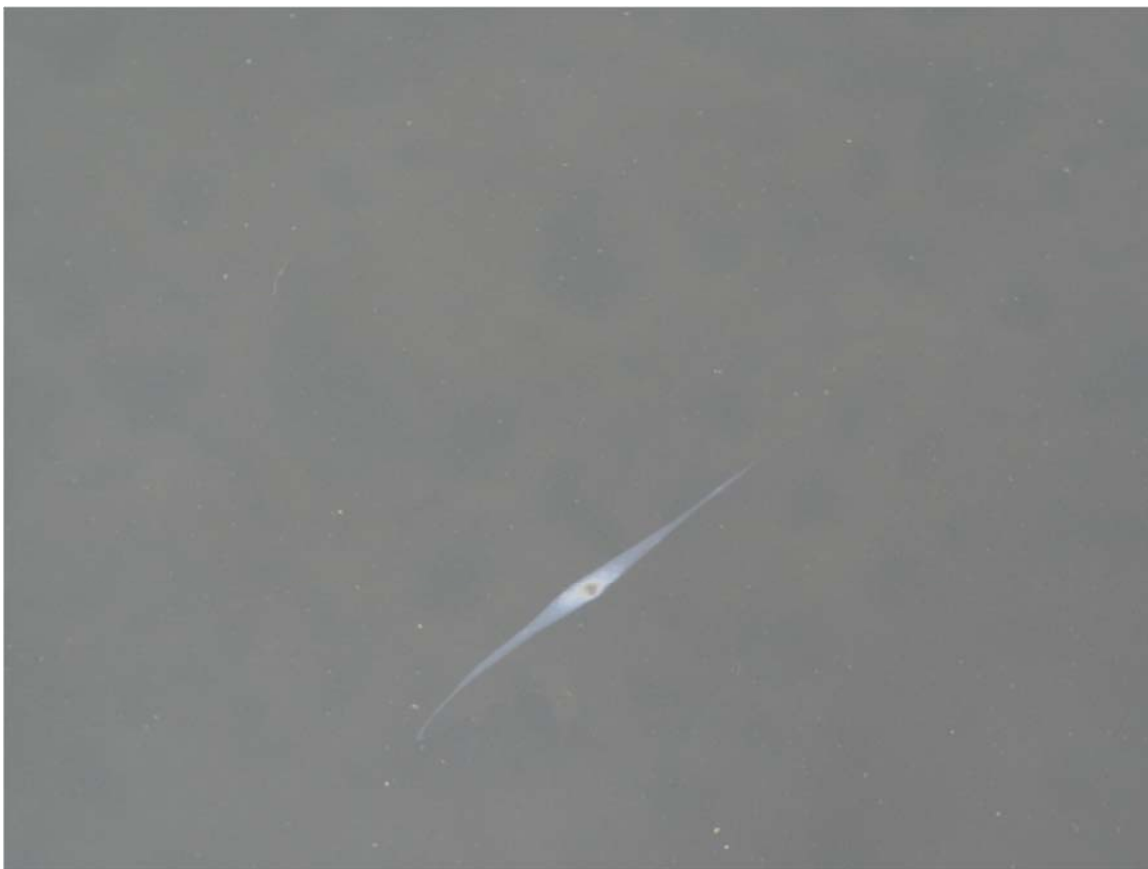
**26. Morrow Lake North Cove sheen and tar globs observed. Sheen sweep requested.**
